# Manhole Inspection Summary

Manhole # S31K\_\_014MH

**Location** Address: **S Paca St**

Cross Street: **Warner St**

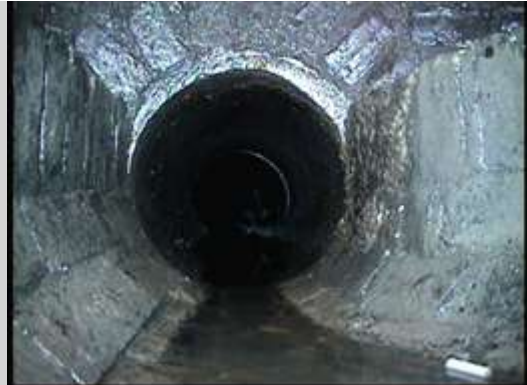
12 O'Clock Outflow

Pipe Height: **10.8** (in.) Rod and Bar (Angled)  
Pipe Material: **Clay** ☐ Pipe Lined  
Invert Depth: **14.60** (ft.) Flow Characteristics: **Slow**  
Deposits: ☒ None ☐ Mud ☐ Sludge ☐ Debris ☐ Grease  
Silt Depth: **0** (in.) Deposits Extent:  
Infiltration: **None** Pipe Seal Cond: **Sound**

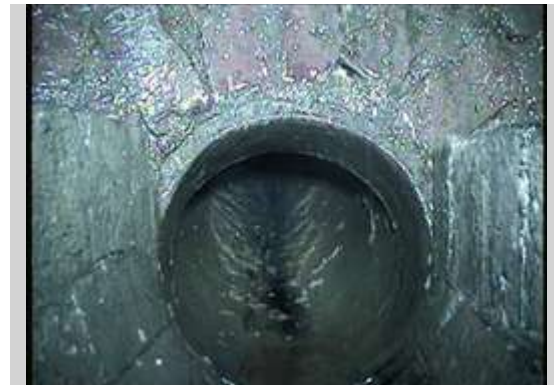
Drop In @ 3 O'Clock

Drop: **Outside** Rod and Bar  
Angled: **Yes** Reading: **13.31** (ft.)  
Inv Depth: **14.31** (ft.)  
Drop Condition: **Open**

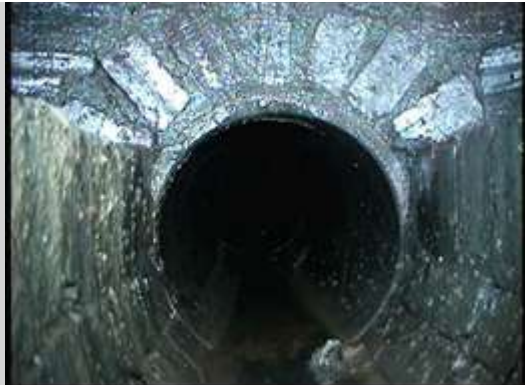
6 O'Clock Inflow

Pipe Height: **10.8** (in.) Rod and Bar (Angled)

Infiltration: **None** Pipe Seal Cond: **Sound**
